In situ monitoring of corrosion processes by coupled micro-XRF/micro-XRD mapping to understand the degradation mechanisms of reinforcing bars in hydraulic binders from historic monuments

Cite this: *J. Anal. At. Spectrom.*, 2015, 30, 721

***In situ* monitoring of corrosion processes by coupled micro-XRF/micro-XRD mapping to understand the degradation mechanisms of reinforcing bars in hydraulic binders from historic monuments**

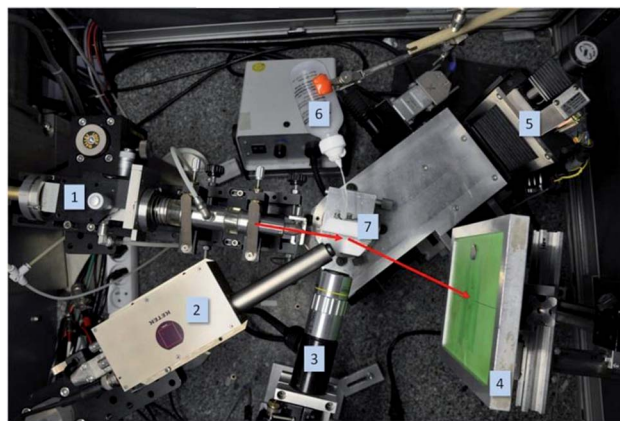
Fig. 2 The *in situ* monitoring set-up on a rotating anode X-ray generator: 1. X-ray (Mo, $\lambda_{K\alpha} = 0.709 \text{ \AA}$), 2. XRF detector, 3. OM, 4. image plate, 5. translation table, 6. chlorinated solution, 7. cell.

Set-up on a rotating anode X-ray generator. For the micro-XRD measurements, a Mo anticathode of a rotating anode X-ray generator delivered a monochromatic beam at 17.48 keV focused to a 50 $\mu\text{m} \times 30 \mu\text{m}$ surface (flux of about 10^6 ph s^{-1}) using a Xenocs® FOX2D Mo 25_25P diffraction optic (Fig. 2). This optic is a curved mirror with graded multilayer coatings that monochromatizes the incident beam from a single reflection. The cells were placed at an angle of 3° from the incident beam in order to work in reflection mode, and the spot size at the sample surface was about 1000 μm (horizontal finger print due to incident angle) $\times 30 \mu\text{m}$. Diffraction patterns were collected during about 1 h 30 min using a two-dimensional detector (image plate). Data processing was carried out with the EVA software and the ICDD-JCPDS database. XRF analysis was acquired using a silicon drift detector.
